## Case study of a patient suffering from Venous Insufficiency on the right leg treated with Qurion and Jet Force

### Case Study Details:

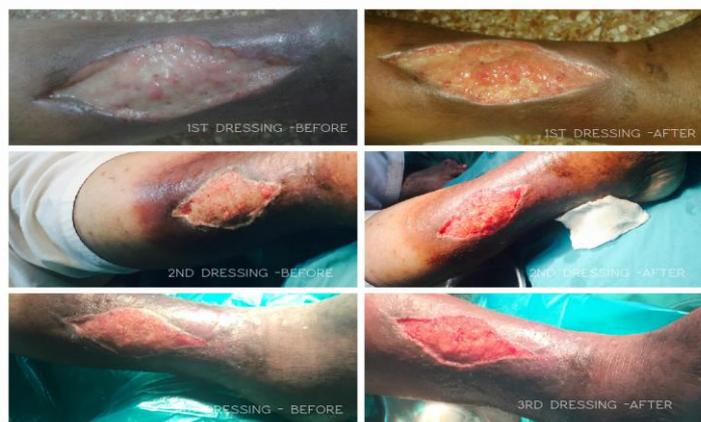
The wound progress has been shown in the pictures below:

**Wound condition after the combination treatment:** The combination treatment of Qurion with Jet Force was started with an every week dressing ritual, whereas, alternate day dressing was done with Qurion alone. The wound improved in following regards:

1. Wound size started to reduce
2. Pain level decreased
3. New skin started to develop on the wound edges with fresh granulation seen
4. The color of the wound started to change from yellow to red as new blood vessels began forming.

The healing process was relatively slow as the patient was obese which led to the adipose tissue become hypoxic from lack of angiogenesis and hence the wound did not come to complete closure. The treatment with Qurion is still on-going along with Gentamycin injections given on a weekly basis.
